## Test Report

1. Determine the drain efficiency of PermaFlow compared to conventional Polypropylene P-Trap with melted grease at 1.5gpm

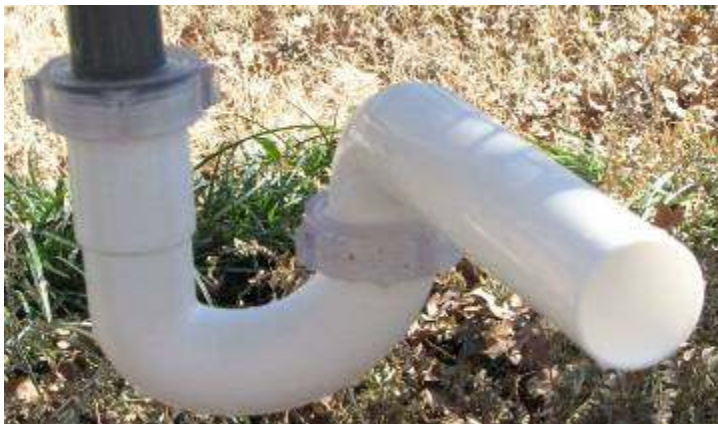
Test 1 – 1-1/2 gpm - Conventional P-trap –Grease

P-trap completely blocked with melted grease

Observations – The P-trap completely blocked with grease. No flow was established even with a full sink of water standing for 36 hours. The P-trap had to be removed for cleaning.

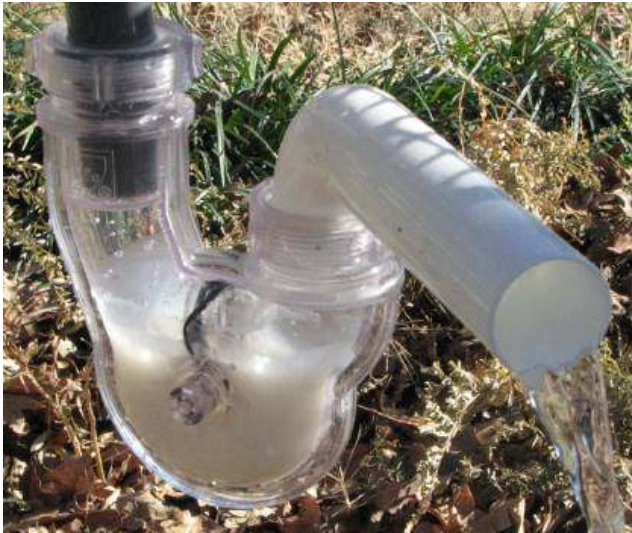
Test 2 – 1-1/2 gpm – PermaFLOW - Grease

PermaFLOW filled to above axle with grease. Flow still maintained via the bypass around the wiper.

Observations – Even though PermaFlow maintained flow and the by-pass position was effective, the best practice would be to remove the PermaFLOW for thorough cleaning when convenient. Since, PermaFLOW is clear – the blockage material can be seen easily and solution implemented appropriately.

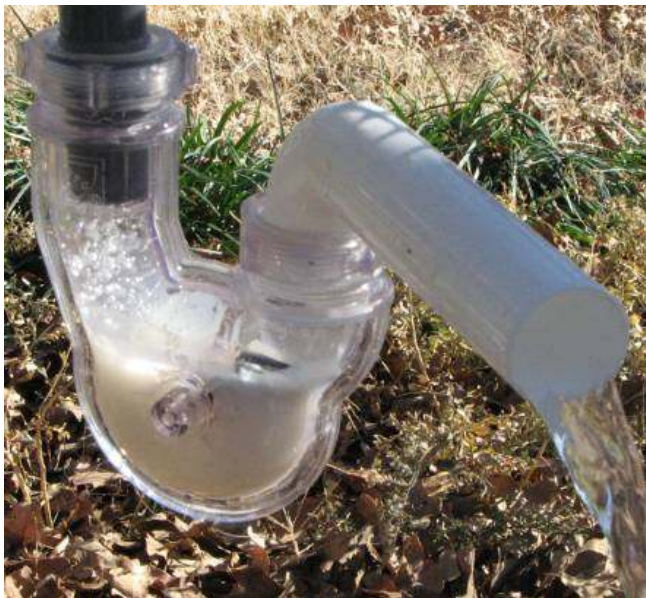
PermaFLOW rotated to by-pass position. Full flow established.
